**Flood Control Project Maintenance
Levee Inspections**
LMA District Cover Sheet
Spring 2017 Levee Inspection Results

Sutter Maintenance Yard Hamilton Bend

Waterway			Bank	Unit Miles
Unit No. 01 Feather River Hamilton Bend			Right	3.39
	Spring (March - May)	Summer (June - August)	(September - November) Fall	Winter (December - February)
Unit Maintenance Rating (Fall Only)				
Date of Inspection	3/23/2017 - 3/23/2017			
DWR Inspector	Sterling York			
Accompanied By	Shawn Freitag Sutter Maintenance Yard

Levee Inspection Report By Mile - Spring 2017

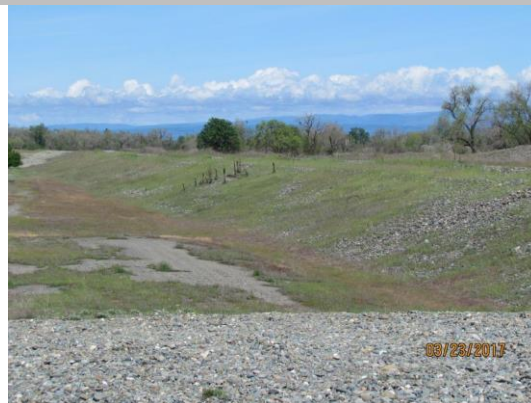
Photo 1 of 1 : SP_2017_ST0005_289_12_20170327_00016.jpg

LM Start	0.01	Rating **	A/W	Issue No.	12
LM End	1.22	Issue Type +	Ma	Location *	LS
Category	Earthen Levee			GPS Latitude/Longitude	
				Start	End
Item	Vegetation			39.439831 °	39.456815 °
				-121.641453 °	-121.639324 °
DWR ID	DWR_ST0005_01_s_2017_12				
Comment Code					
V1 : Control annual grass and weeds on the levee slopes and easements.					
Inspector Comment					
Controlled annual vegetation.

View of well maintained vegetation, land side looking upstream. Spring 2017.

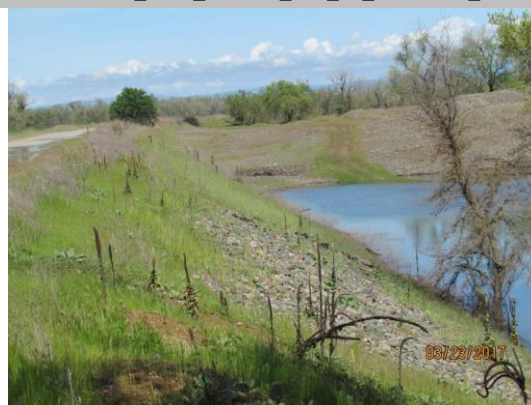
Photo 1 of 1 : SP_2017_ST0005_289_17_20170327_00017.jpg

LM Start	0.01	Rating **	A/W	Issue No.	17
LM End	1.22	Issue Type +	Ma	Location *	WS
Category	Earthen Levee			GPS Latitude/Longitude	
				Start	End
Item	Vegetation			39.439832 °	39.456802 °
				-121.641454 °	-121.639315 °
DWR ID	DWR_ST0005_01_s_2017_17				
Comment Code					
V1 : Control annual grass and weeds on the levee slopes and easements.					
Inspector Comment					
Controlled annual vegetation.

View of well maintained vegetation, water side looking upstream. Spring 2017.

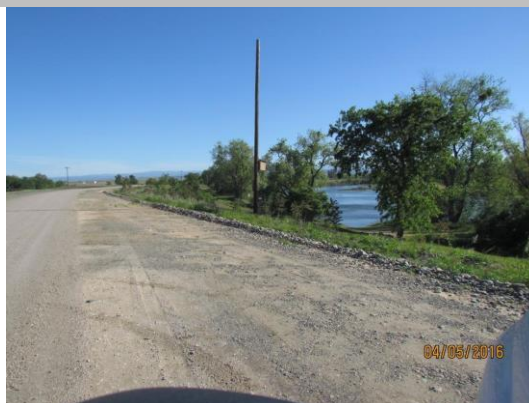
Photo 1 of 1 : SP_2017_ST0005_289_14_20170316_00008.jpg

LM Start	0.73	Rating **	M	Issue No.	14	
LM End	0.91	Issue Type +	En	Location *	WS	
Category	Earthen Levee			GPS Latitude/Longitude		
				Start		End
Item	Encroachments			39.450109 °		39.452643 °
				-121.640851 °		-121.640316 °
DWR ID	DWR_ST0005_01_s_2016_14					
Comment Code						
TR : Tree or limb						
Inspector Comment						
Trees smaller than 4" in diameter at chest height should be removed before they get any bigger.

View looking upstream of trees. Small trees 4" in diameter at chest height should be removed before they get to big., Spring 2016.

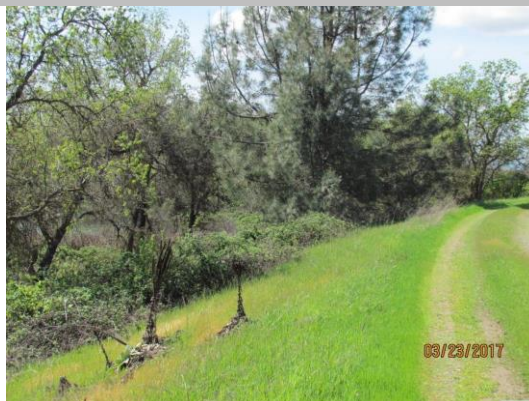
Photo 1 of 1 : SP_2017_ST0005_289_18_20170327_00020.jpg

LM Start	1.48	Rating **	U	Issue No.	18
LM End	1.68	Issue Type +	Ma	Location *	WS
Category	Earthen Levee			GPS Latitude/Longitude	
				Start	End
Item	Trim / Thin Trees			39.458053 °	39.459462 °
				-121.636300 °	-121.633817 °
DWR ID	DWR_ST0005_01_s_2017_18				
Comment Code					
T3 : Trim and thin trees to allow visibility of the ground and room to flood fight.					
Inspector Comment					
From Levee Mile 1.38 to 3.39 has never been maintained by the LMA

View of thick trees and vegetation blocking visibility on waterside, looking downstream. Spring 2017.

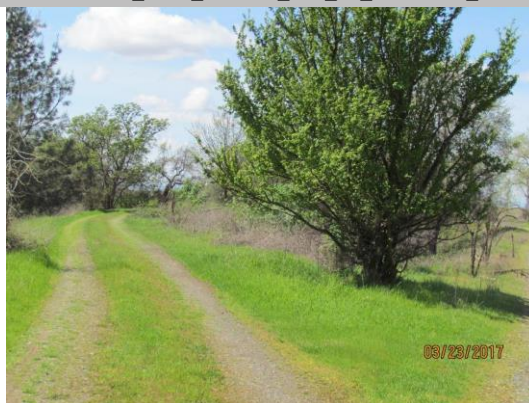
Photo 1 of 1 : SP_2017_ST0005_289_11_20170327_00019.jpg

LM Start	1.48	Rating **	U	Issue No.	11
LM End	1.68	Issue Type +	Ma	Location *	LS
Category	Earthen Levee			GPS Latitude/Longitude	
				Start	End
Item	Trim / Thin Trees			39.458055 °	39.459455 °
				-121.636300 °	-121.633822 °
DWR ID	DWR_ST0005_01_s_2017_11				
Comment Code					
T3 : Trim and thin trees to allow visibility of the ground and room to flood fight.					
Inspector Comment					
From Levee Mile 1.38 to 3.39 has never been maintained by the LMA

View of thick trees blocking visibility on landside, looking downstream. Spring 2017.

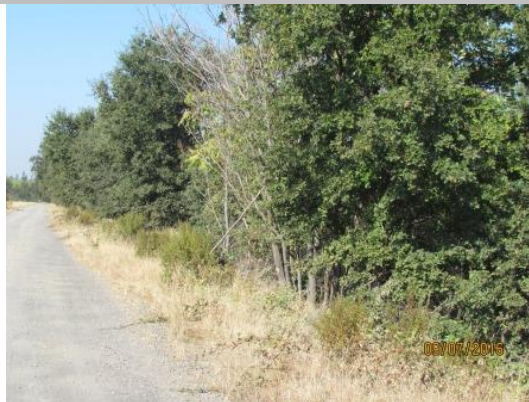
Photo 1 of 1 : SP_2017_ST0005_289_3_20170316_00001.jpg

LM Start	2.53	Rating **	U	Issue No.	3
LM End	3.24	Issue Type +	Ma	Location *	LS
Category	Earthen Levee			GPS Latitude/Longitude	
				Start	End
Item	Trim / Thin Trees			39.465532 °	39.470155 °
				-121.620753 °	-121.609241 °
DWR ID	DWR_ST0005_01_f_2016_3				
Comment Code					
T2 : Thin trees to allow visibility of the ground and room to flood fight.					
Inspector Comment					
From Levee Mile 1.38 to 3.39 has never been maintained by the LMA

Very dense trees and limbs that completely obstruct visibility and flood fight access to the levee slope and the landside easement.

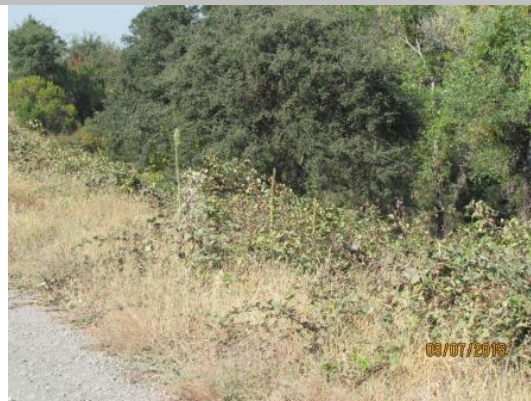
Photo 1 of 1 : SP_2017_ST0005_289_6_20170316_00004.jpg

LM Start	2.63	Rating **	U	Issue No.	6
LM End	2.63	Issue Type +	Ma	Location *	LS
Category	Earthen Levee			GPS Latitude/Longitude	
				Start	End
Item	Vegetation			39.466025 °	39.466025 °
				-121.618972 °	-121.618972 °
DWR ID	DWR_ST0005_01_f_2016_6				
Comment Code					
V2 : Remove the wild growth other than native grasses from the levee slopes.					
Inspector Comment					
Blackberries covering slope. From Levee Mile 1.38 to 3.39 has never been maintained by the LMA.

View of blackberries that are covering the landside slope.

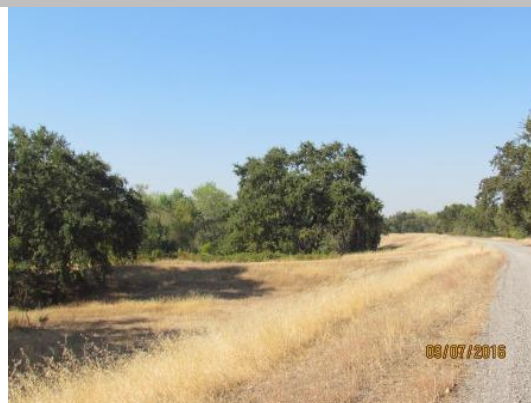
Photo 1 of 1 : SP_2017_ST0005_289_23_20170316_00009.jpg

LM Start	2.93	Rating **	M	Issue No.	23
LM End	3.09	Issue Type +	Ma	Location *	WS
Category	Earthen Levee			GPS Latitude/Longitude	
				Start	End
Item	Vegetation			39.468492 °	39.469304 °
				-121.614417 °	-121.611733 °
DWR ID	DWR_ST0005_01_s_2016_23				
Comment Code					
V1 : Control annual grass and weeds on the levee slopes and easements.					
Inspector Comment					
Annual grasses need to be maintained. From Levee Mile 1.38 to 3.39 has never been maintained by the LMA.

View of annual grasses that need to be maintained.
